TECHNICAL REPORT

NO. 12498

FORMATION AND FAILURE OF
ELASTOMER NETWORKS VIA
THERMAL, MECHANICAL AND
SURFACE CHARACTERIZATION

by DAVID W. DWIGHT & JAMES E. McGRATH

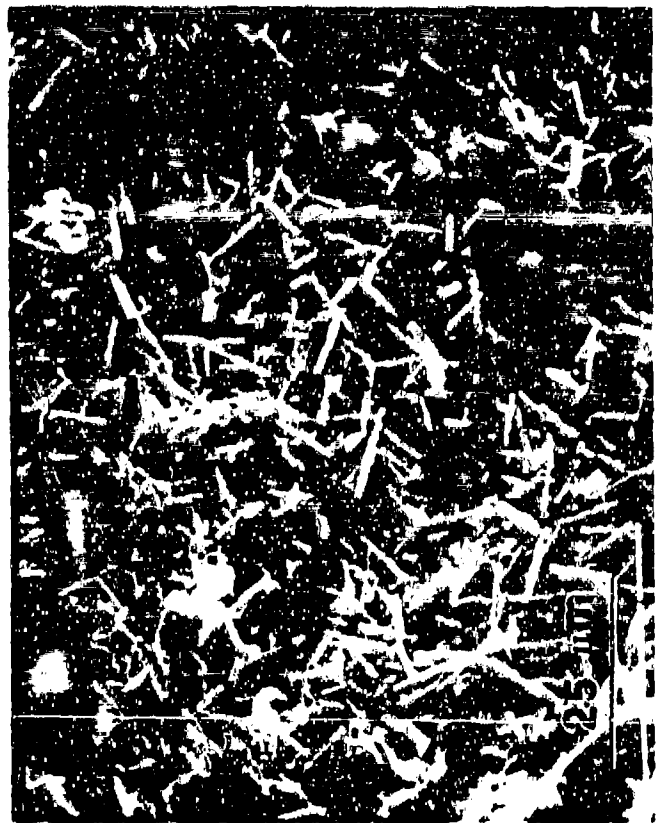
Figure 8

EDAX detected Al, Cl, Si, K, Ca, Fe, and Zn in the bulk and in the particles on the surface. The needle-like particles shown in fractographs are confirmed by ESCA and EDAX to be zinc oxide as was suspected. The agglomeration of ZnO particles on the failure surfaces could certainly be involved in the premature failure of the track pads. These layers appear to be primarily "aliphatic" material derived from the polydiene component of the SBR. The presence of the ZnO particles suggest that the blending of the rubber with the compounding ingredients, is inadequate. More intensive mixing with longer time cycles are suggested.

Fracture surfaces derived from tensile test specimen showed no ZnO particles on the fracture surfaces of the controlled St. Joe materials. On the other hand, the ZnO particles were observed on the surfaces of the failed pads. It would be of interest to observe whether inhomogeneities

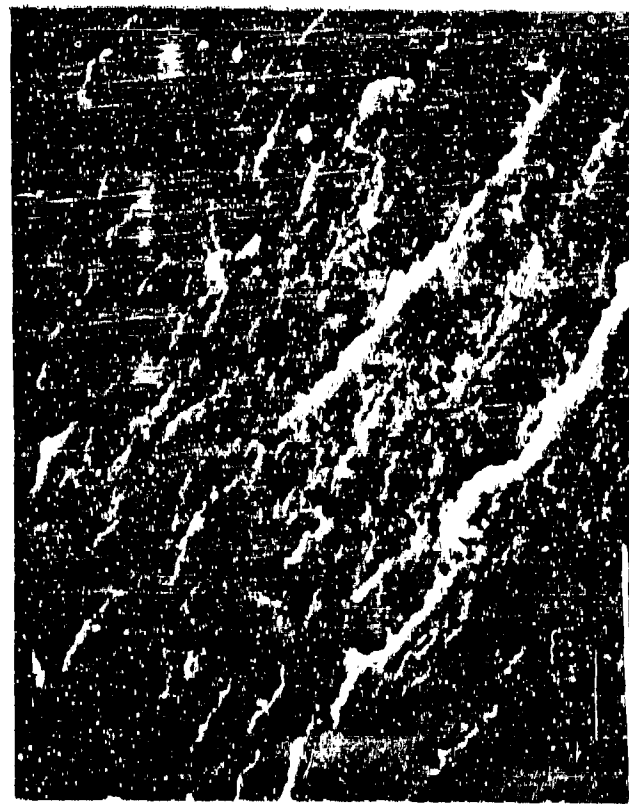
Figure 11

Each of the St. Joe samples was failed in tension, before and after exposure to 325°C for 5 and 10 minutes, and about 75% and 90% drop in stress-strain properties was noted. However, SEM examinations of all fracture surfaces never showed ZnO, even in the case of high aspect-ratio, acicular particles. Presumably this reflected very good mixing, which should be emulated by the commercial elastomer systems.
